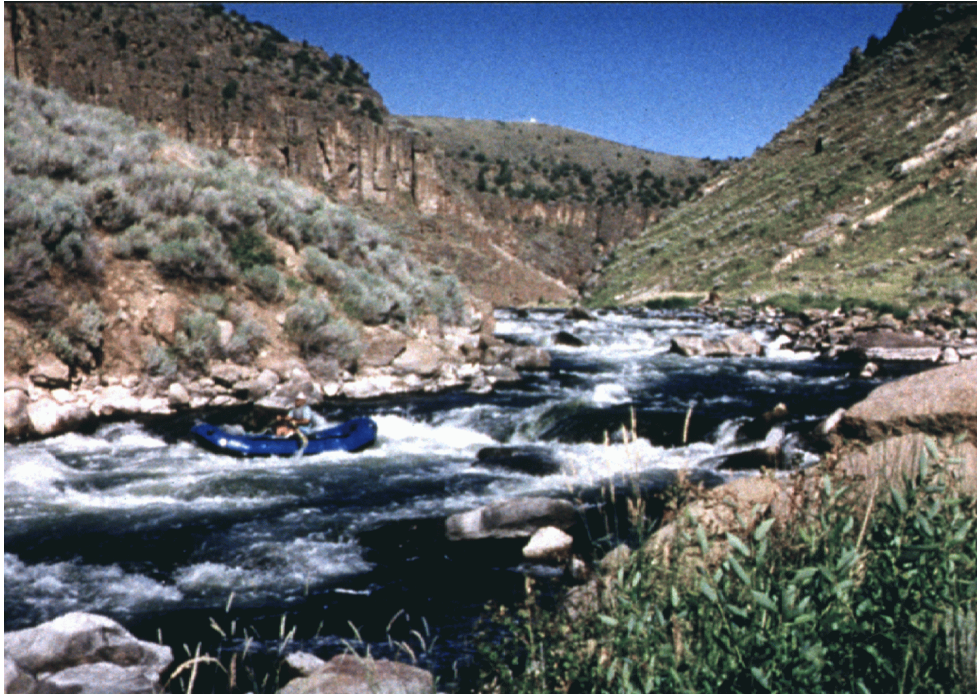
*Photograph A- 23. Along the right bank of rapid 27, older sage covered colluvium. USBR photograph by Ralph Klinger, 1998.*

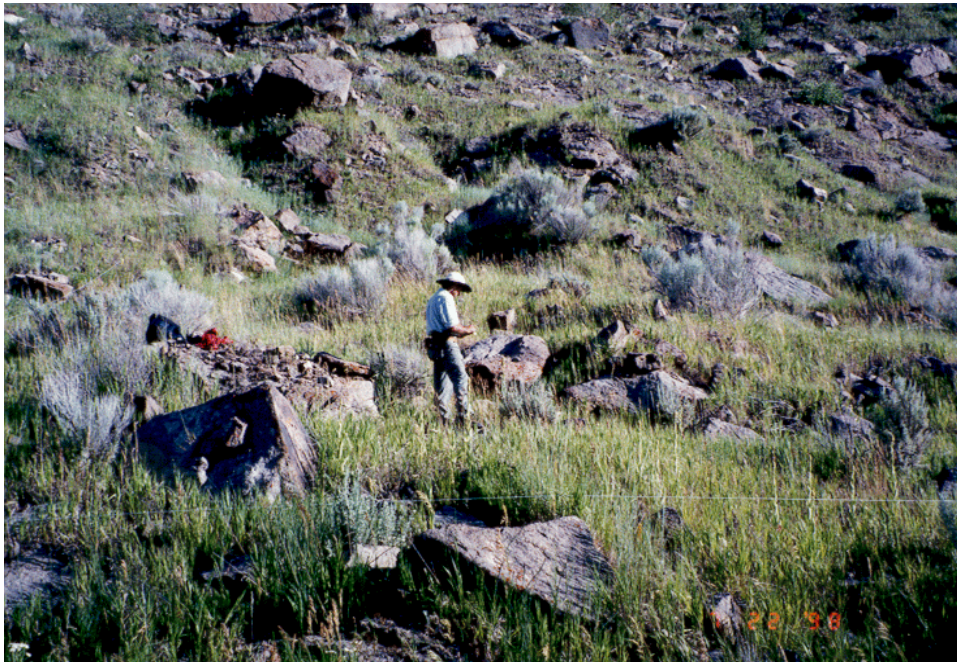
*Photograph A- 24. A size count estimate of landslide material was made on the left bank of rapid 27. Two counts were made in a 10,000 - square- foot grid at this site. USBR photograph by A.C. Lockhart, July 22, 1998.*

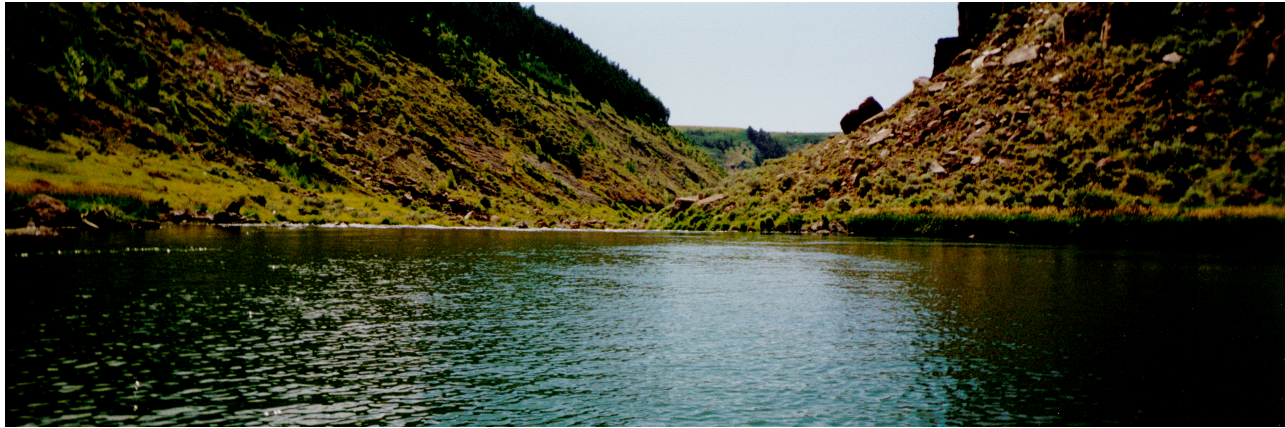
*Photograph A- 25. Existing pools, riffles, and rapids are numbered from the upstream end of the former reservoir area (mouth of Bitch Creek) to the dam site in ascending order. Pool 27, formed by rapid 27, is a short (500 feet) and fairly wide (250 feet) pool. This view is looking downstream. USBR photograph by Tim Randle, 1998.*

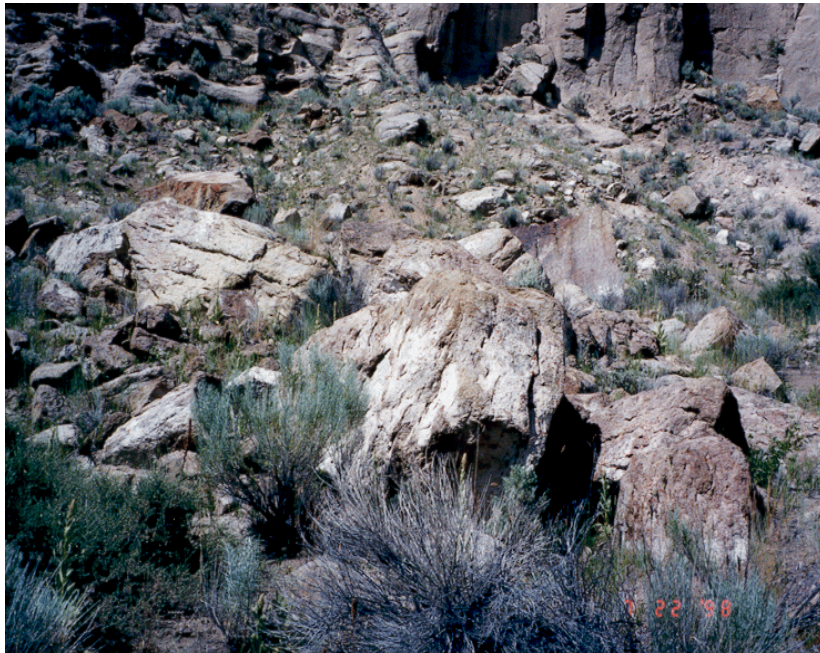
*Photograph A- 26. View of rockfall on the north canyon wall upstream of rapid 27. The majority of the material ranges in size from cobbles (3 inches to 12 inches) to small boulders (1.0 feet to 3 feet). The large blocks of rock are 2 feet to 5 feet in diameter. USBR photograph by A.C. Lockhart, July 22, 1998.*

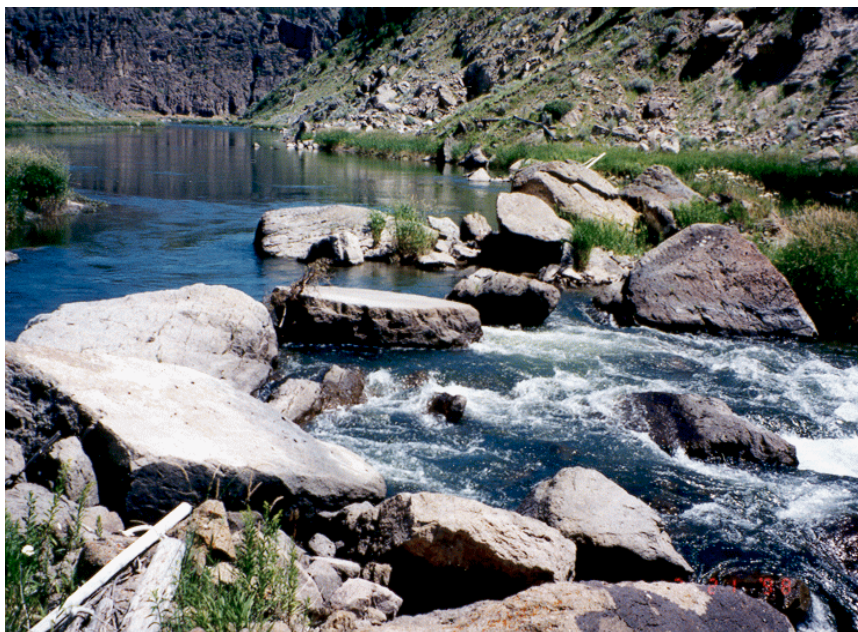
*Photograph A- 27. Rapid 26 was formed from landslide material that moved into the river from the north canyon wall. Over time, the river has cut through the slide debris, transporting fine- grained material downstream and leaving large blocks of rock that back up pool 26. USBR photograph by A.C. Lockhart, July 22, 1998.*

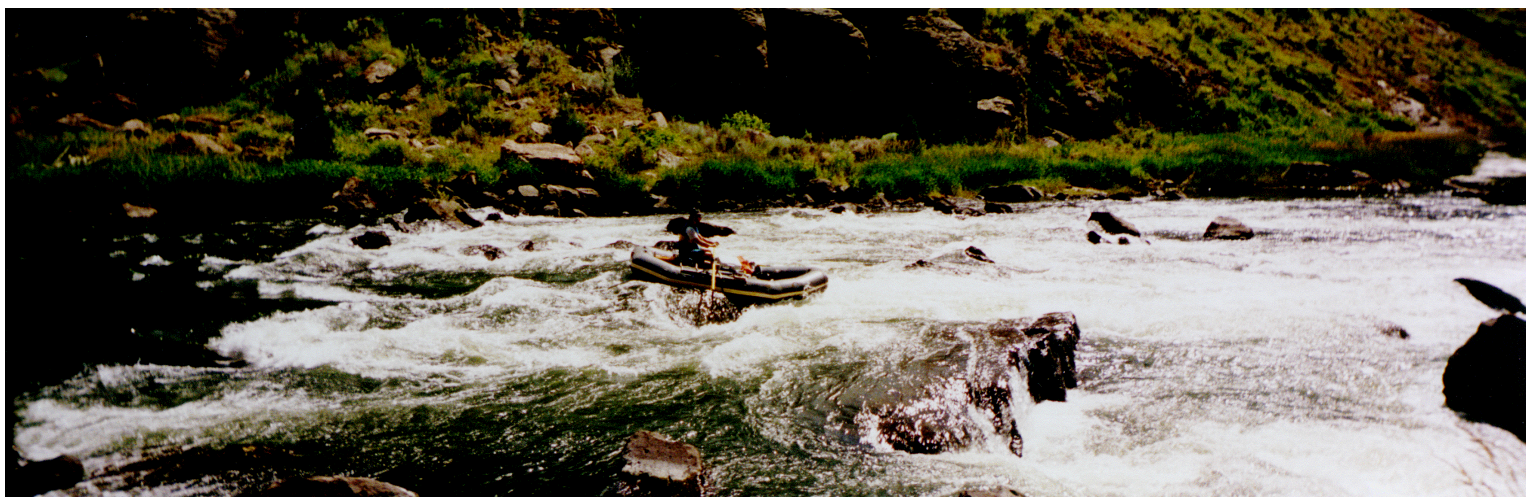
*Photograph A- 28. The drop through rapid 25 was measured to be over 3½ feet. USBR photograph by Tim Randle, 1998.*

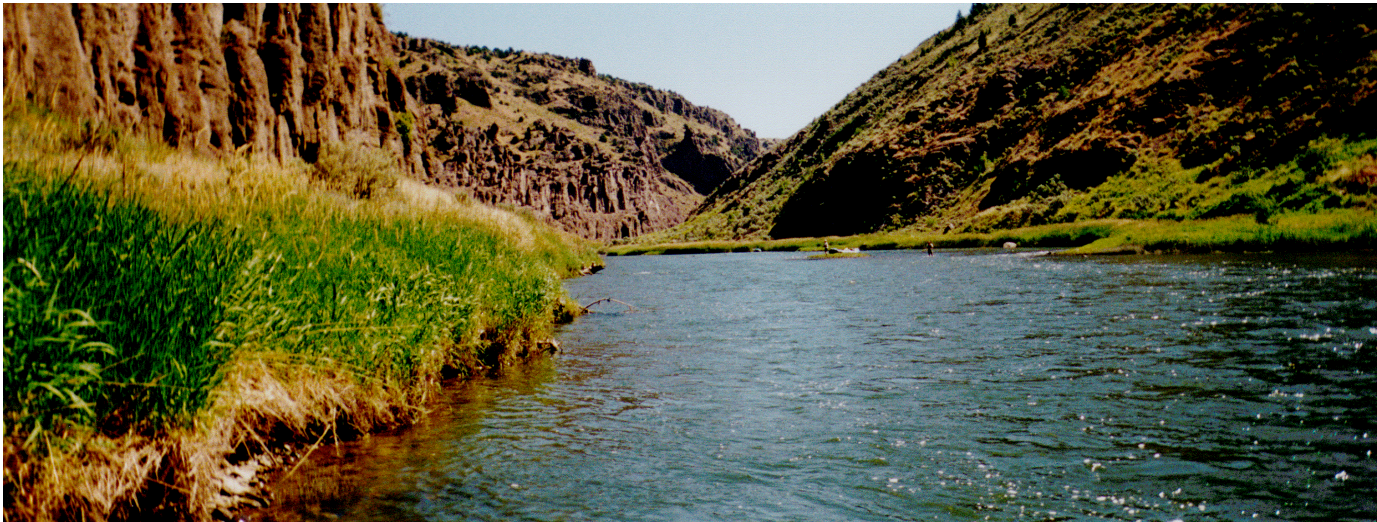
*Photograph A- 29. Pool 23 starts just downstream of a long series of riffles and is approximately 2,850 feet long. Pool 23 marks the beginning of the nearly 2- mile- long reach with the most change. This view is looking upstream of a 90- degree bend in the river. USBR photograph by Tim Randle, 1998.*

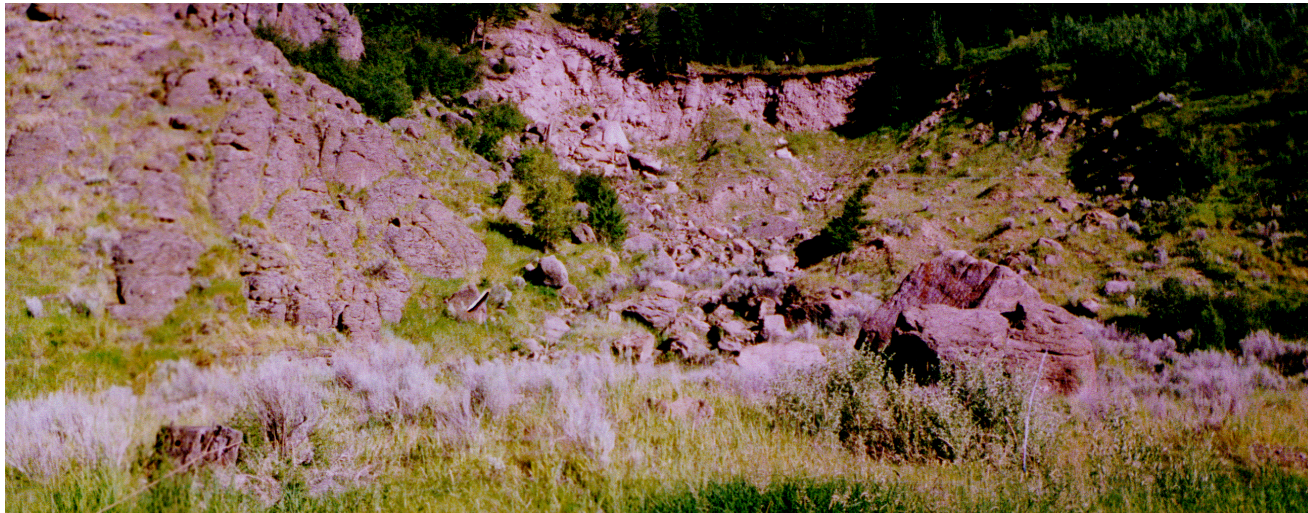
*Photograph A- 30. The landslide headscarp on the left canyon wall and debris that formed rapid 22. USBR photograph by Tim Randle, 1998.*
